BETHESDA TERRACE:  
CONDITIONS ASSESSMENT AND EVALUATION OF PREVIOUS STONE  
CONSERVATION TREATMENTS

A THESIS

Historic Preservation

1998

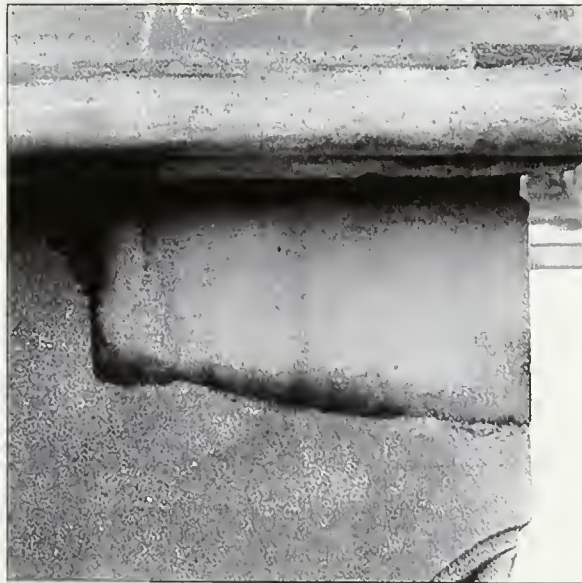
**Fig. 1 - Composite repair showing signs of visual alterations.**

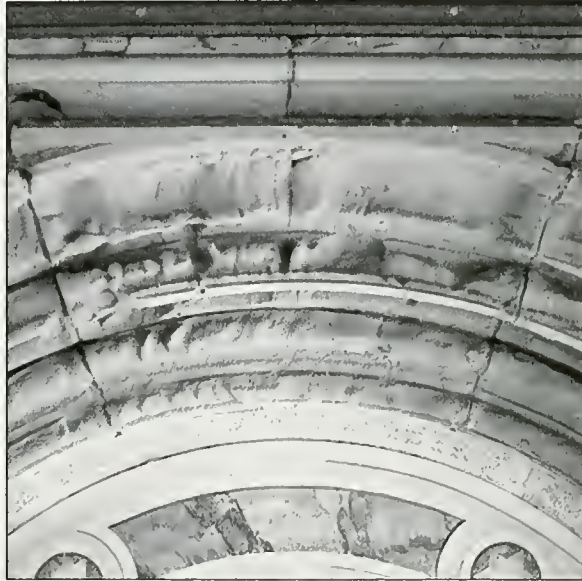
**Fig. 5 - Retroweathering - uniform back loss parallel to the original stone surface due to various weathering determined at individual occurrences.**

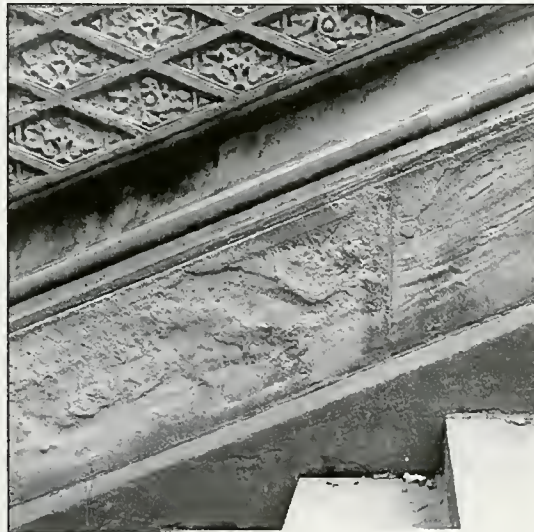
**Fig. 6 - Retroweathering - retroweathering on wall panel base of north arcade stair.**

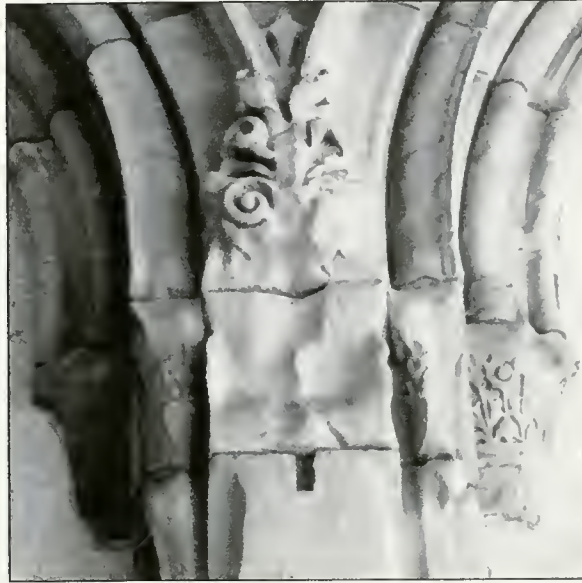
**Fig. 7 - (1b.a) Rounding/notching - concave/convex weathering forming soft edges and hollowed areas.**

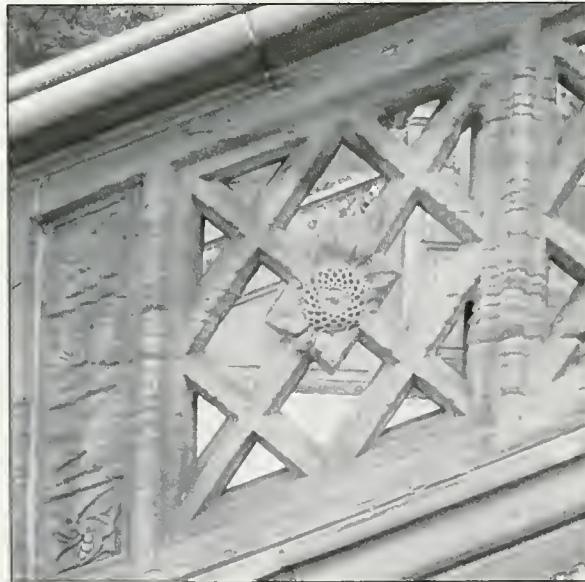
**Fig. 8 - (1b.c) Weathering pattern dependent on stone structure - relief of stone surface caused by weathering dependent on structural features such as bedding.**

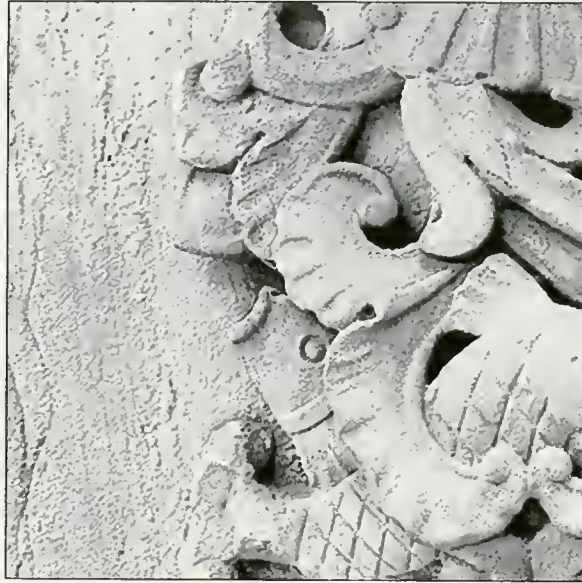
**Fig. 9 - (1b.d) Exposure of stone components - raised exposure of stone aggregate through loss of less stable stone components.**

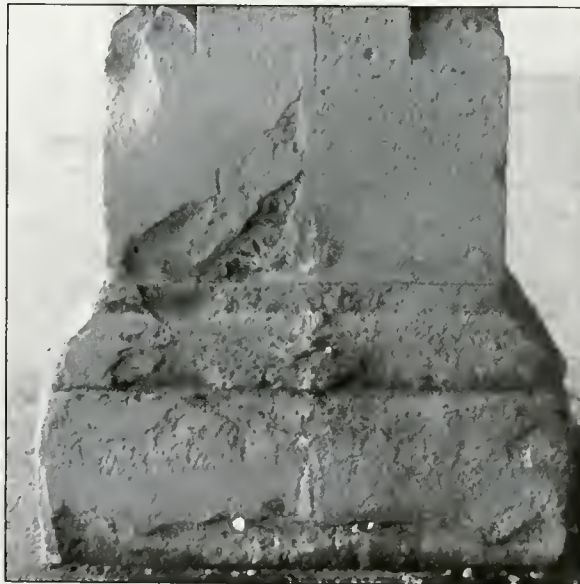
**Fig. 10 - (1b.e) Roughening – alteration of original stone surface causing loss of smoothness, gloss or original tooling marks.**

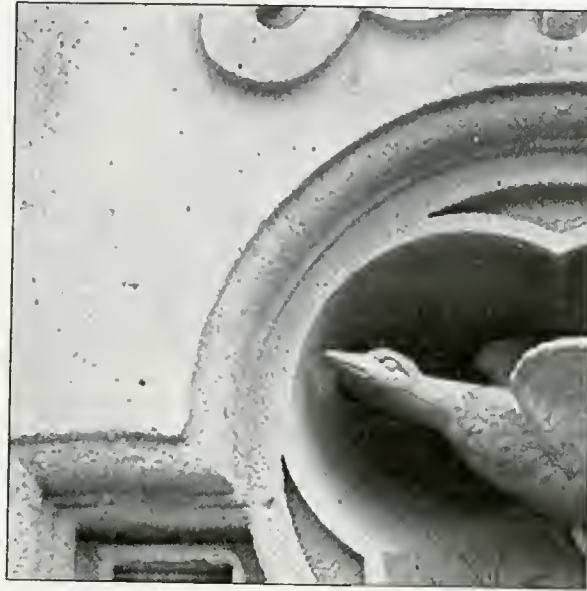
**Fig. 11 - (1b.g) Pitting – alteration of stone surface resulting in pitted areas where less stable components weather out of the stone.**

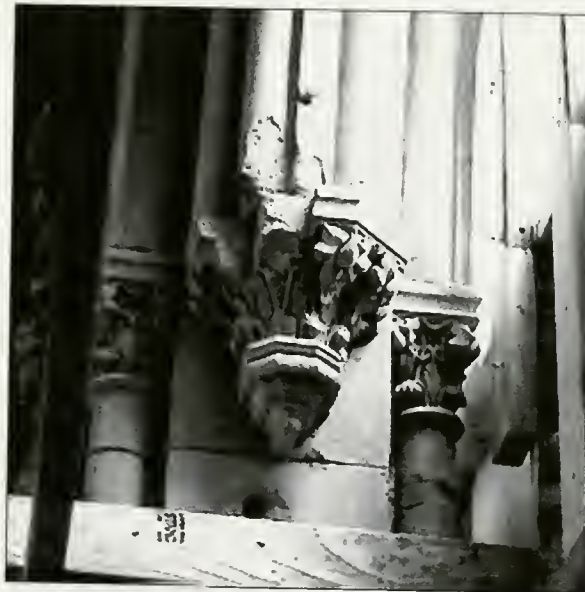
**Fig. 12 - (1c) Breakage due to direct anthropogenic influence.**

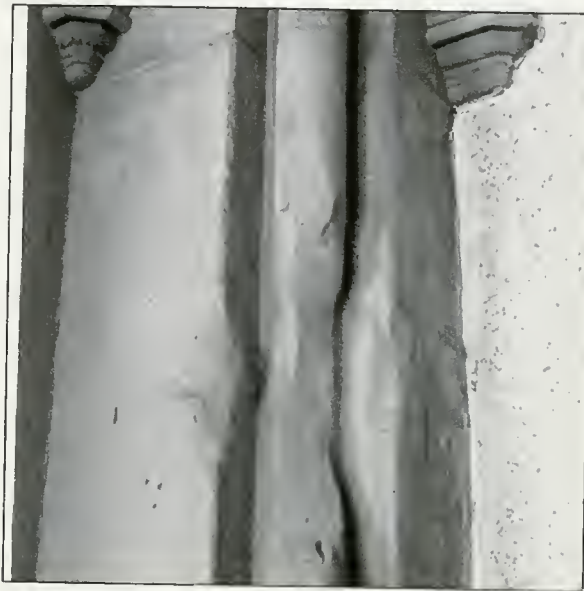
**Fig. 13 - (1c.d) Breakage resulting from unrecognizable causes.**

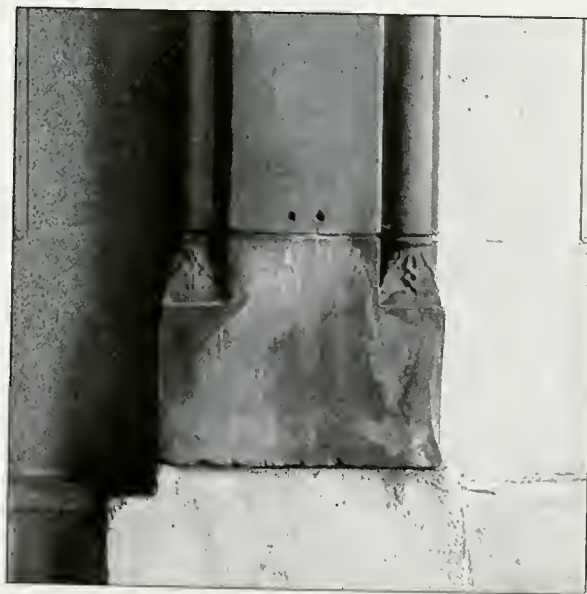
**Fig. 14 - (2a.a) Coloration - chromatic alteration of original stone surface resulting from accumulation of coloring matter through natural weathering or chemical treatments.**

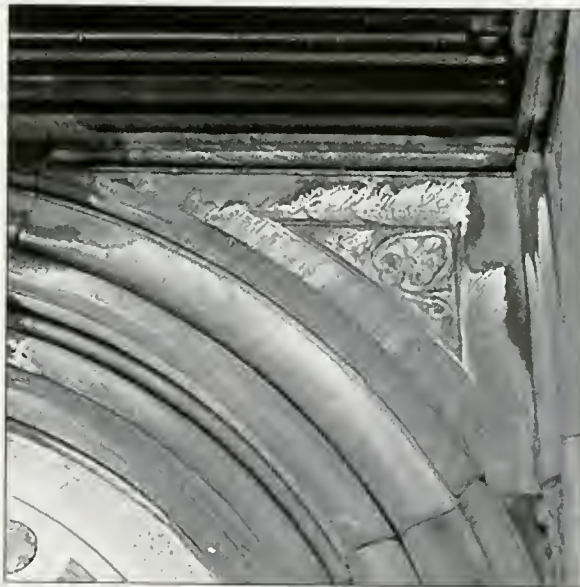
**Fig. 18 - (2c.a) Efflorescence - loose salt deposits on stone surface.**

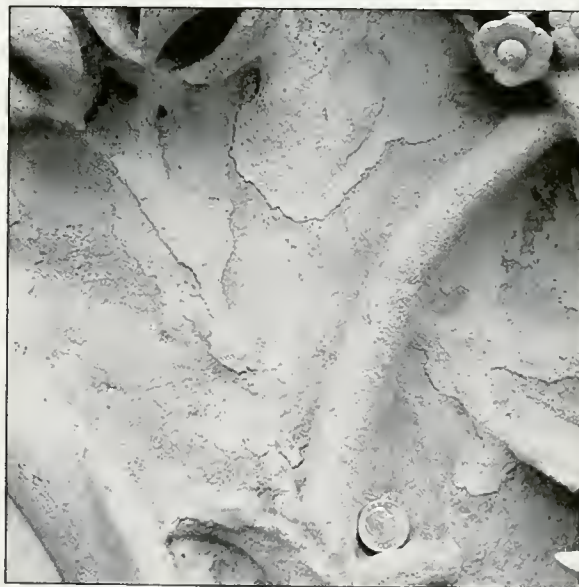
**Fig. 22 - (3d.b) Flaking resulting in multiple flakes - detachment of multiple layers of flaking parallel to the stone surface.**

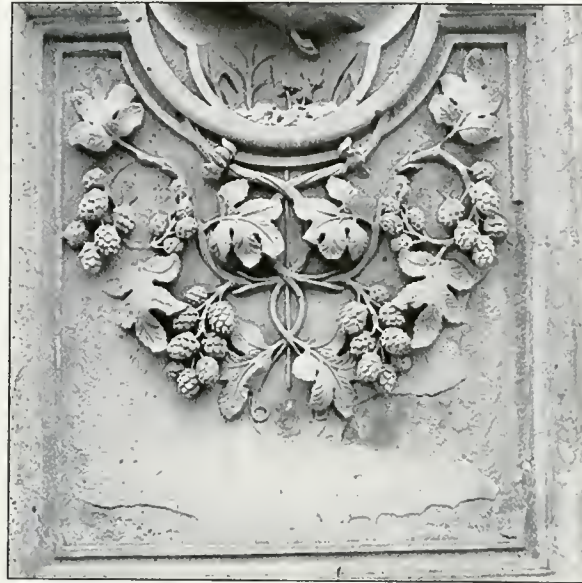
**Fig. 23 - (3f.b) Delamination - detachment of larger stone elements parallel to stone structure, but not necessarily to stone surface.**

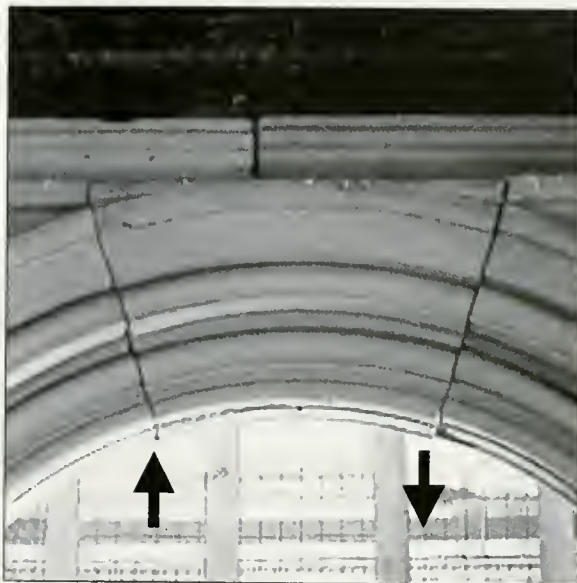
**Fig. 24 - (4b) Displacement - stone elements from moved from original location due to natural or anthropogenic causes.**

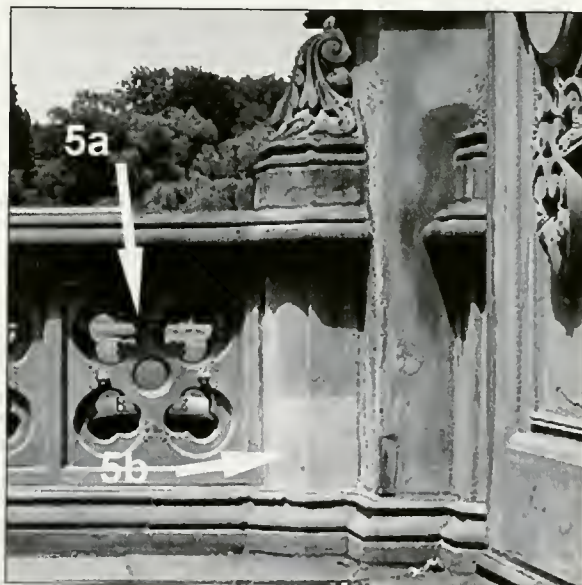
**Fig. 25 - (5a) Stone replacement - replacement of stone with new stone. (5b) Artificial stone replacement/mortar patch - replacement of stone elements with artificial stone or mortars.**

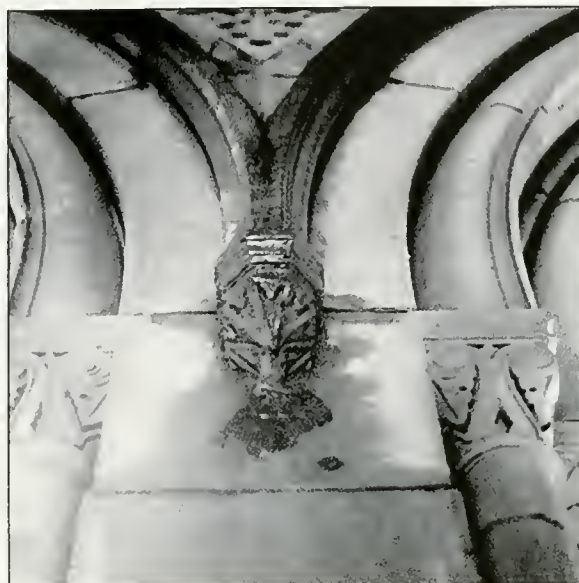
**Fig. 26 - Water penetration on north arcade column.**

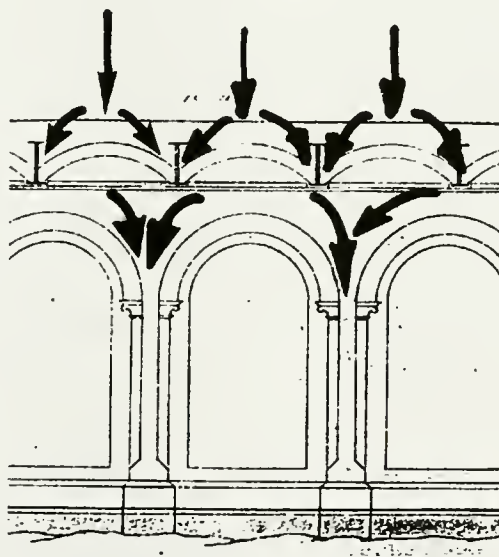
The construction of the shallow barrel vaulting of the arcade ceiling may also create a potential for surface water transport to the sandstone. The iron girders lead water directly from the vaults to the voussiors of the perimeter wall pilasters where it collects at the impost blocks and runs down the pilasters. This mechanism may have been even more pronounced before the removal of the Minton tile ceiling because water was pooling on the backsides of the panels and probably running directly to the stone. The dismantling of the ceiling probably diminished moisture collection and enhanced salt efflorescence as the stone dried.

**Fig. 27 - Path of water penetration through ceiling to voussiors.**

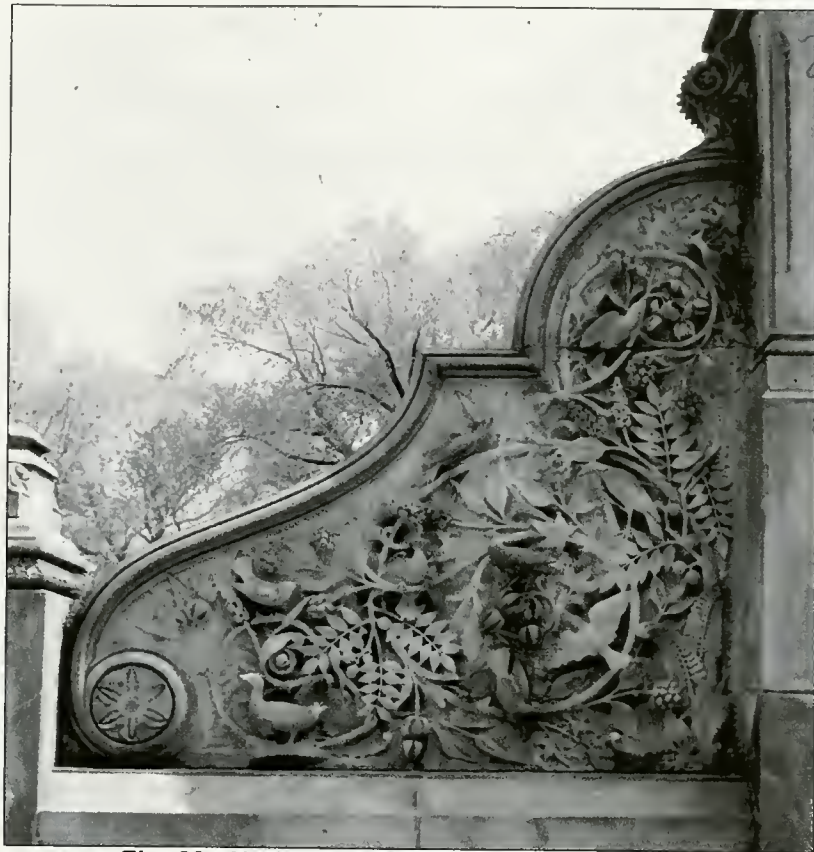
**Fig. 28 - Northwest bird panel, western exposure.  
Note erosion under drip molding along the top.**

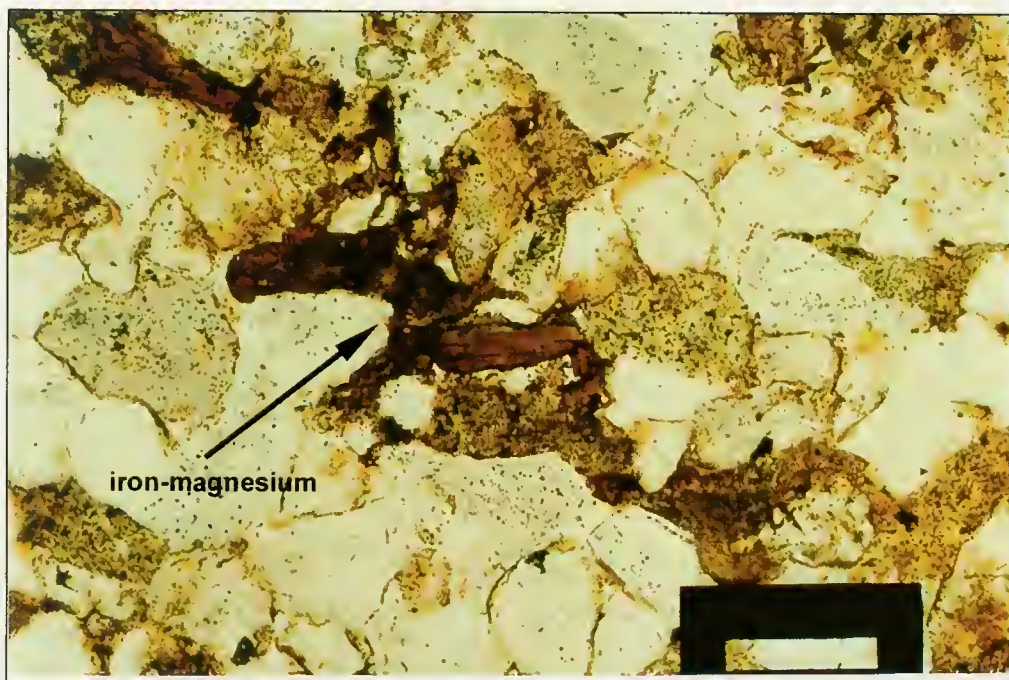
**Fig. 33 - Bethesda Terrace sandstone (100X – plane-polarized light).  
Large inclusion of iron-magnesium in highly altered state.**

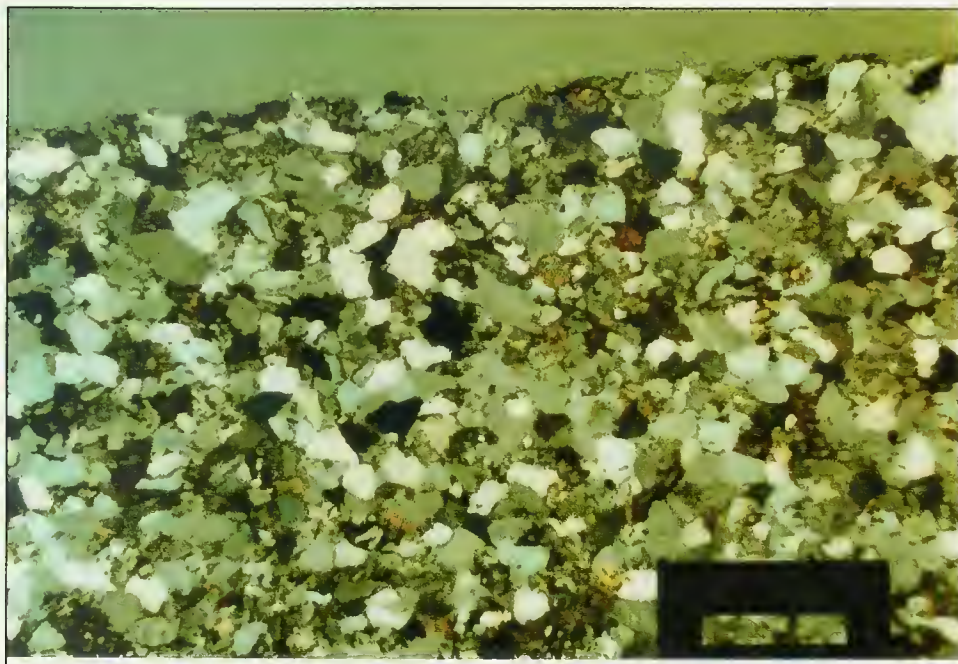
surface of the stone (see figure 43). This visible layer may be a build up of fine debris from either the treatment or weathering. No fractured or compacted crystals were observed in the thin sections (see figure 42).

**Fig. 42 - Honed Surface (50X - plane-polarized light).**  
Note no alteration is visible near the surface of the sample.

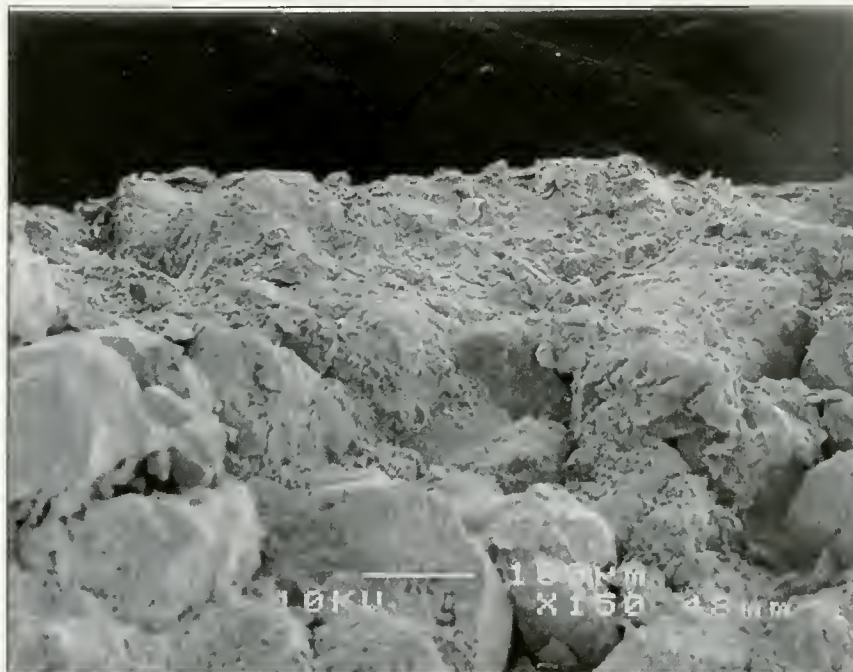
This treatment resulted in a visual unification of the stone surface by removing unstable stone and creating a faceted surface as a function of hand variability during the honing process. Examination with plain light microscopy at 100X and with a scanning electron microscope revealed that a 100  $\mu\text{m}$  thick exists at the

**Fig. 43 - Honed surface (150X - JEOL SEM).**

Visible 100-µm layer may be alteration to the surface of the sandstone from honing or it may be dirt deposit.

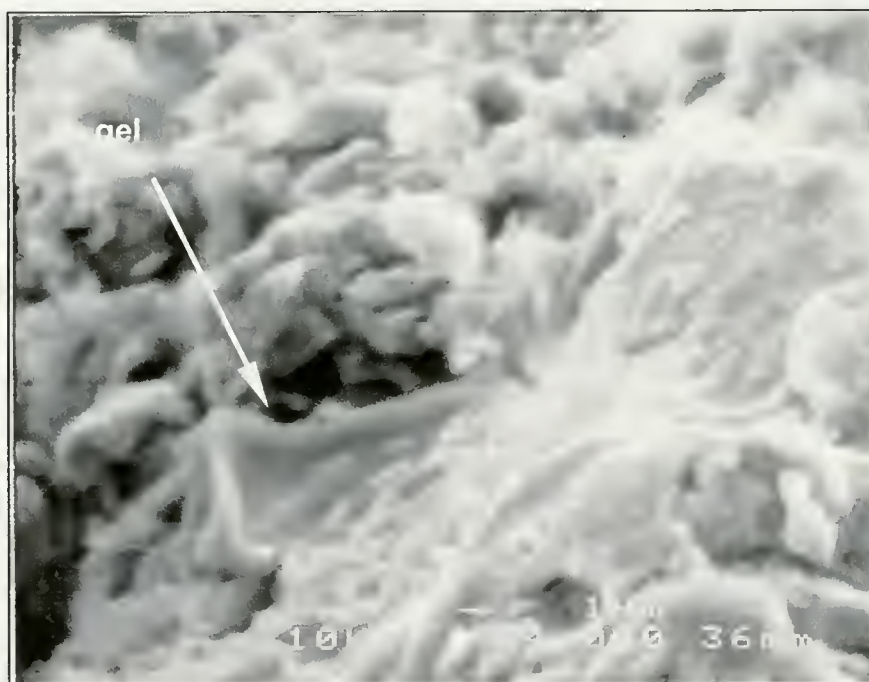
Consolidants applied as experimental treatments in the 1980s still remain in the sandstone of the exterior terrace based on scanning electron microscopy examination. Documentation of the formulation and application of these treatments is vague, however laboratory testing showed that both consolidants are still present and currently reduce capillarity in the areas tested. The application of consolidants did not alter the color of the stone.

**Fig. 44 - Wacker OH™ in Bethesda Terrace sandstone (4,000X - JEOL SEM).**  
Characteristic gel of Wacker OH™ is visible on quartz grains.

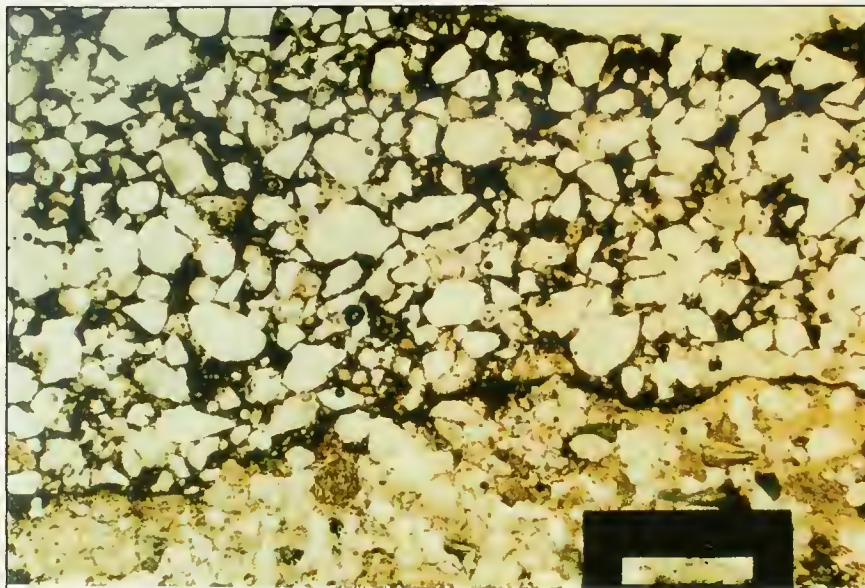
**Fig. 46 - Composite repair – thin section (50X - plane-polarized light).**  
Black coloration is throughout the patching material (top layer) and no calcite crystals are visible in the matrix. No alteration to the sound stone beneath the patch is evident.

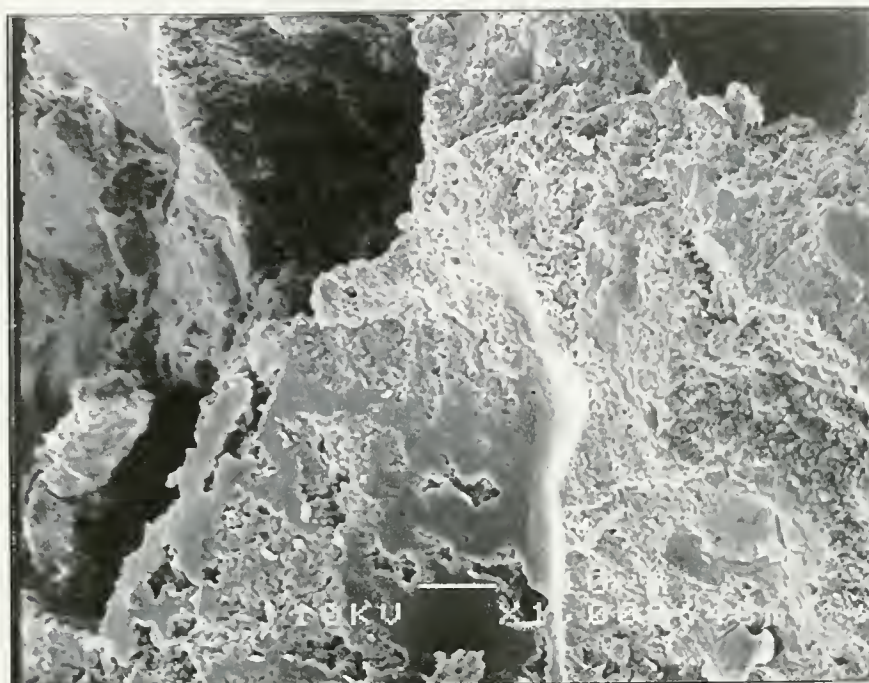
Images of the patching material with SEM confirmed the addition of a non-crystalline substance (see figure 48).

**Fig. 48 - Patching material – (1,000X - JEOL SEM).**

No evidence of biological growth in pores of the stone or on the glassy surfaces, attributed to the presence of an organic component, is visible.

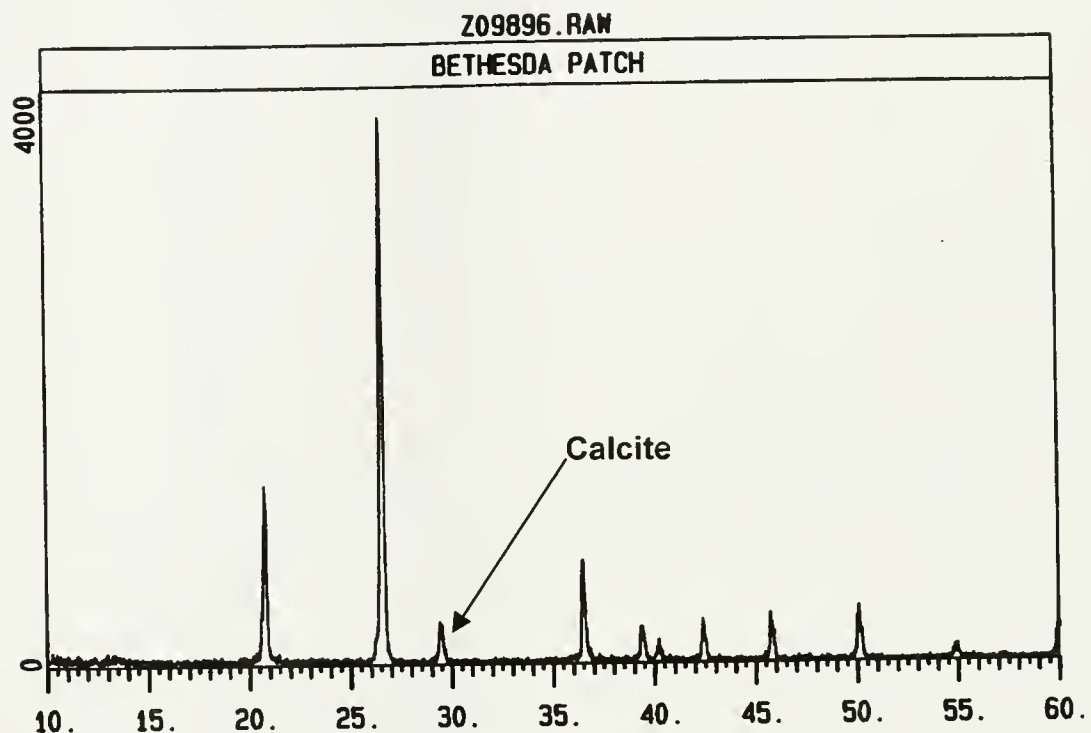
Fig. 48 - XRD Pattern for core sample – P

A sample of composite patching material was removed for XRD analysis from a discolored patch on the north west balustrade of the middle terrace. This sample was flat mounted whole with sculpting putty and scanned at 5°/min. from 10° to 70°. <sup>49</sup> The pattern detected from this sample clearly indicates that the crystalline composed detectable with this technique is  $\alpha$  quartz. A peak for calcite was also identified, confirming the presence of the lime binder in the patching material. This confirms previous information regarding the composition of the composite patching material used in the 1980s restoration as containing sand and lime.

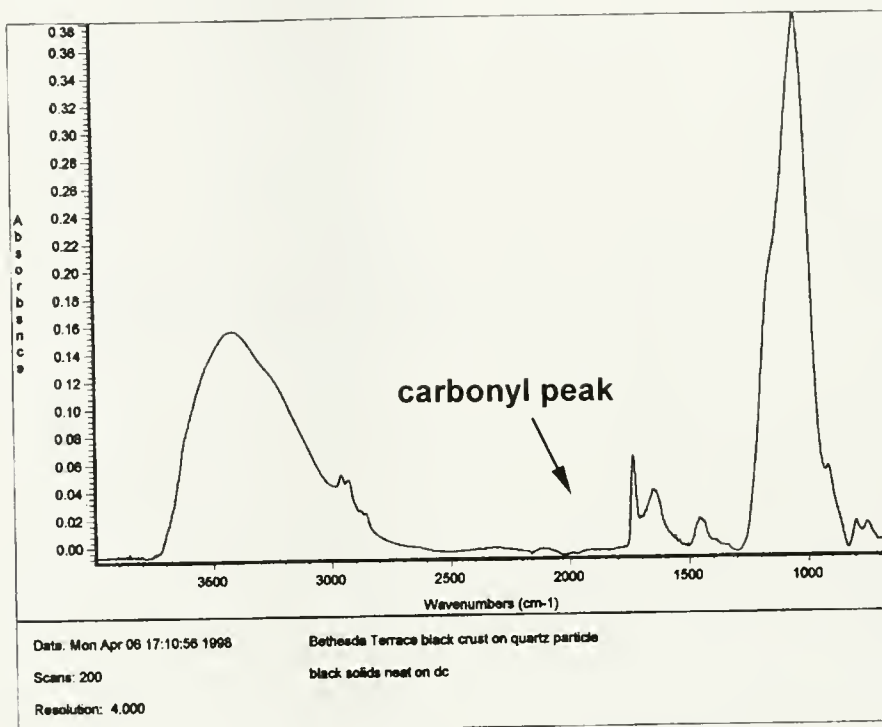
It was suspected that an organic additive was causing the black staining. FTIR analysis of the black crust was conducted.<sup>50</sup> The results showed a high concentration of hydroxides and a high carbonyl peak indicating the presence of organic materials. This peak was isolated and compared to spectra of known organic materials. The closest matches were the Acryloid™ or Rhoplex™ acrylate groups.

Fig. 48 - FTIR spectrum (isolated black stain).

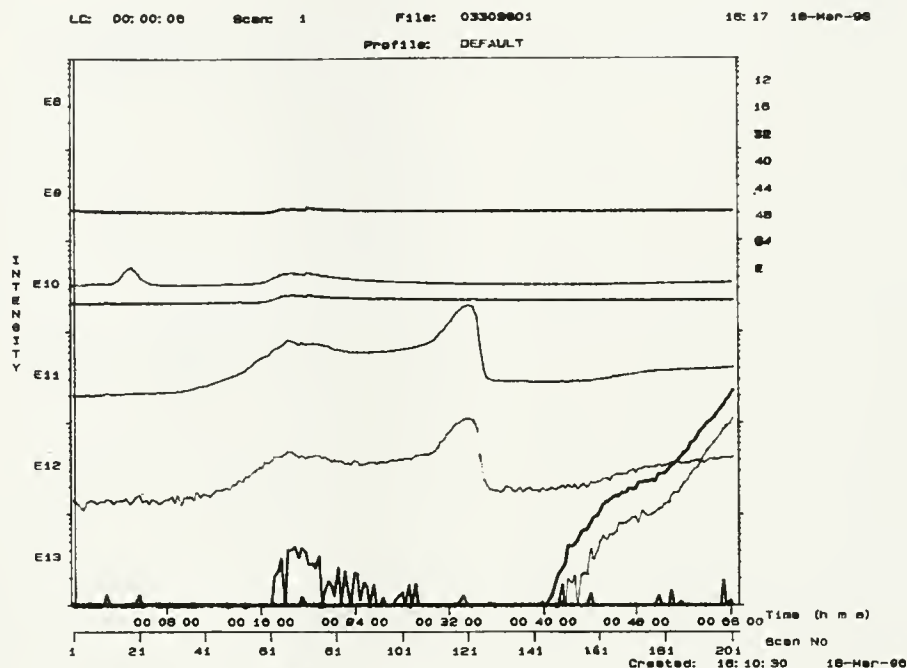
Thermal analyses in combination with mass spectrometry were also used to compliment the FTIR analysis of the organic additives in the patching mortar. Two distinct peaks were obtained in the thermal gravimetric analysis (TGA) and were compared to a sample of methyl methacrylate analyzed with the same methods. One of the peaks resembled the methyl methacrylate, however the second did not. This suggests that the acrylic admixture in the patching material was a combination of two substances.

**Fig. 53 - MS analysis of powdered patching mortar.**  
*Spectrum at max. of organic evolution*

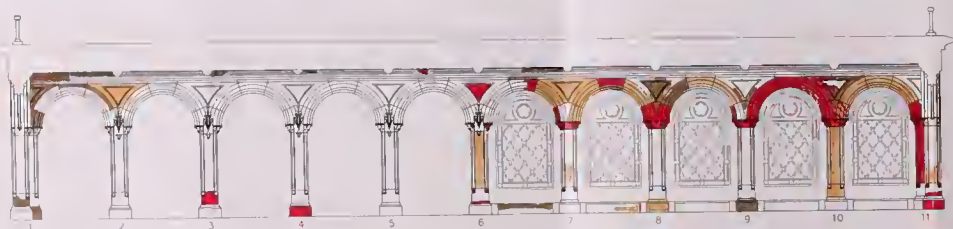
EAST WALL OF CENTRAL ARCADE

DIFFERENTIAL EROSION

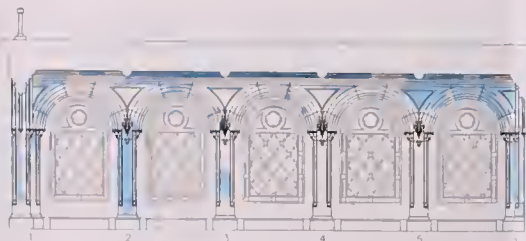
EAST WALL OF EAST LOGGIA

EFFLORESCENCE AND CRUSTS

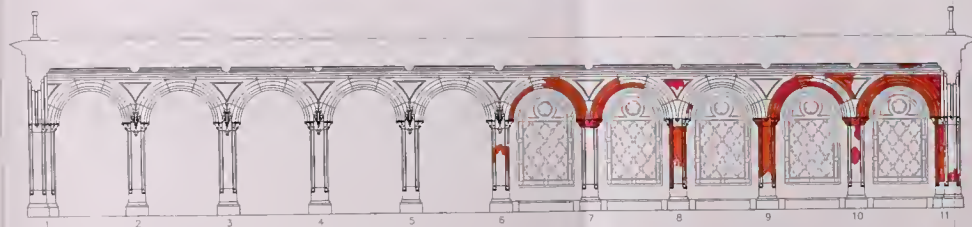
EAST WALL OF CENTRAL ARCADE

FLAKING AND DELAMINATION

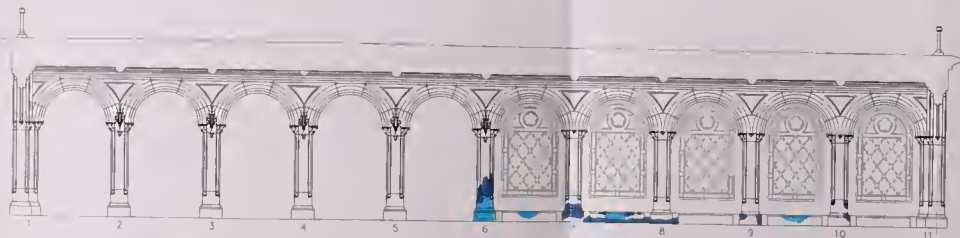
EAST WALL OF CENTRAL ARCADE

PENETRATION DURING RAIN

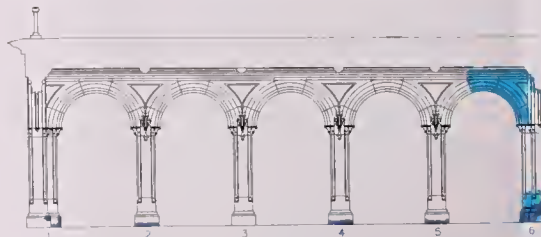
EAST ARCADE OF WEST LOGGIA

PENETRATION DURING RAIN

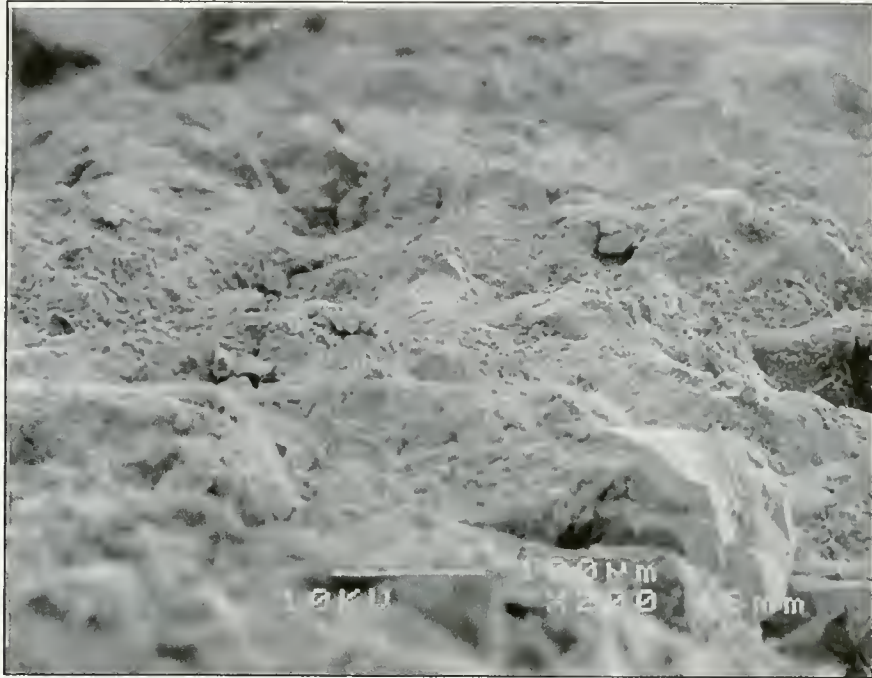
**Fig. 58 - Honed Bethesda Terrace sandstone (200X – JEOL SEM).**  
Honed surface covered by 100µm layer of dust.

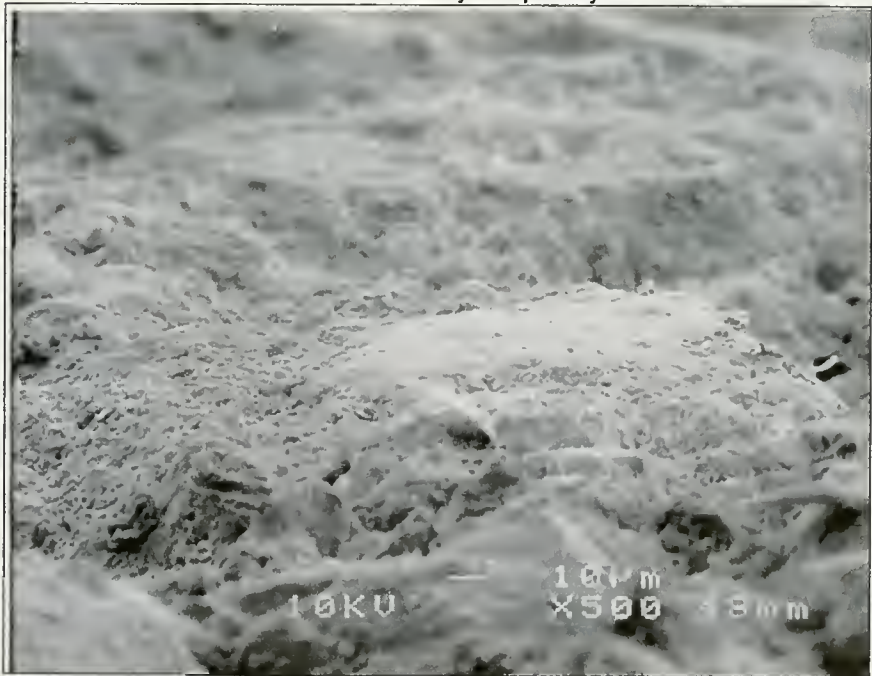
**Fig. 59 - Honed Bethesda Terrace sandstone (500X – JEOL SEM).**  
Dust layer completely covers sandstone grains.

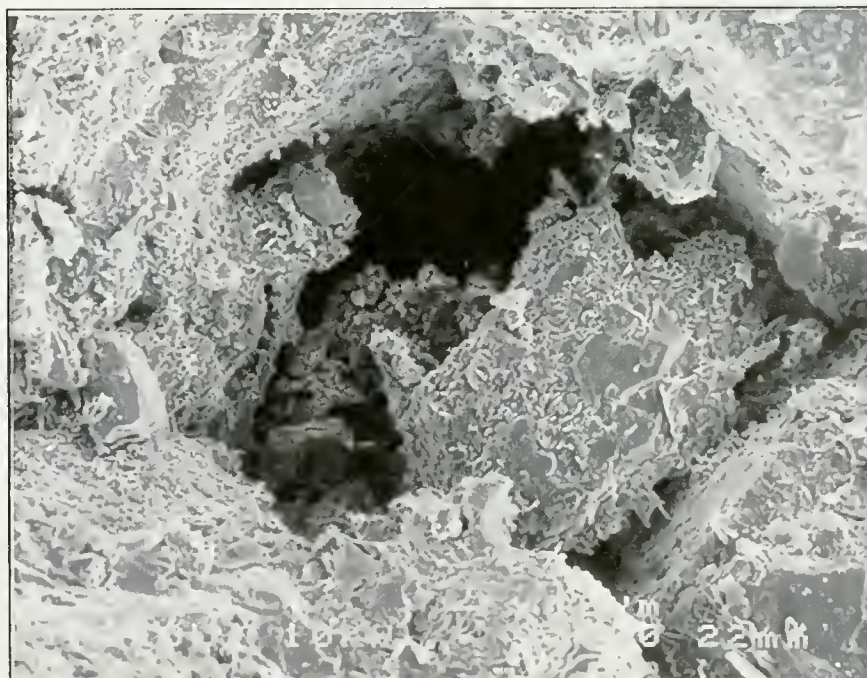
**Fig. 63 - Bethesda Terrace sandstone treated with Wacker OH™ (500X – JEOL SEM).**  
Wacker OH™ is observed in the pores of the Bethesda Terrace sandstone.

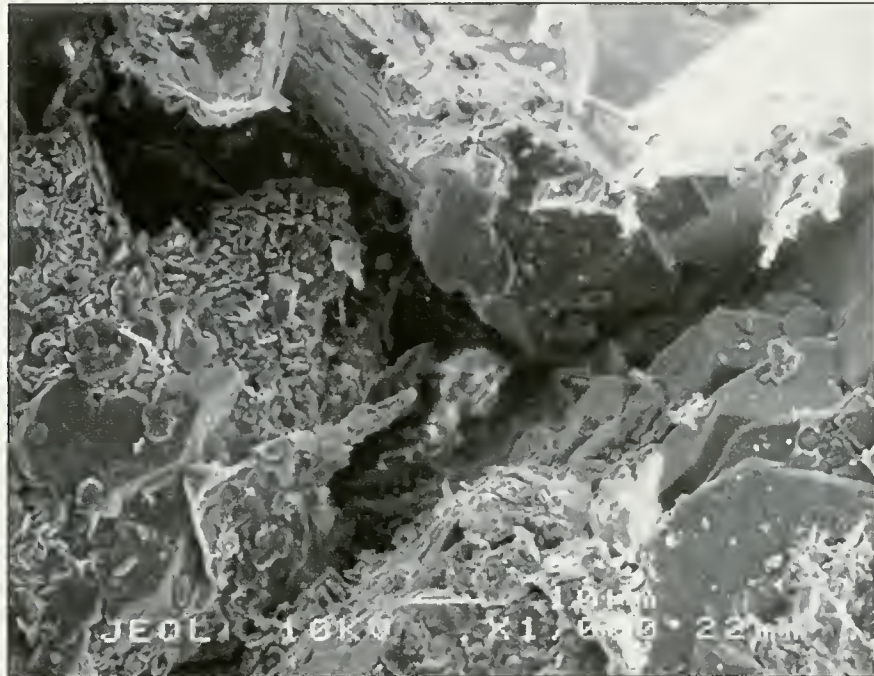
**Fig. 64 - Bethesda Terrace sandstone treated with Wacker OH™ (1,000X – JEOL SEM).**  
Clay particles are coated with Wacker OH.™

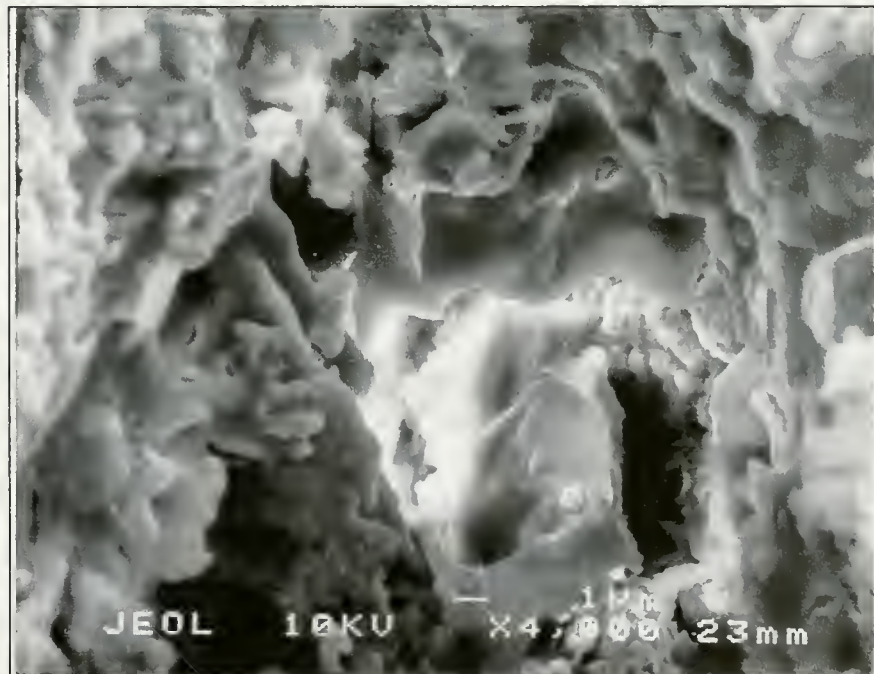
**Fig. 65 - Bethesda Terrace sandstone treated with Wacker OH™ (4,000X – JEOL SEM).**  
Wacker OH™ is observed as a gel coating the surface of the Bethesda Terrace sandstone grains.

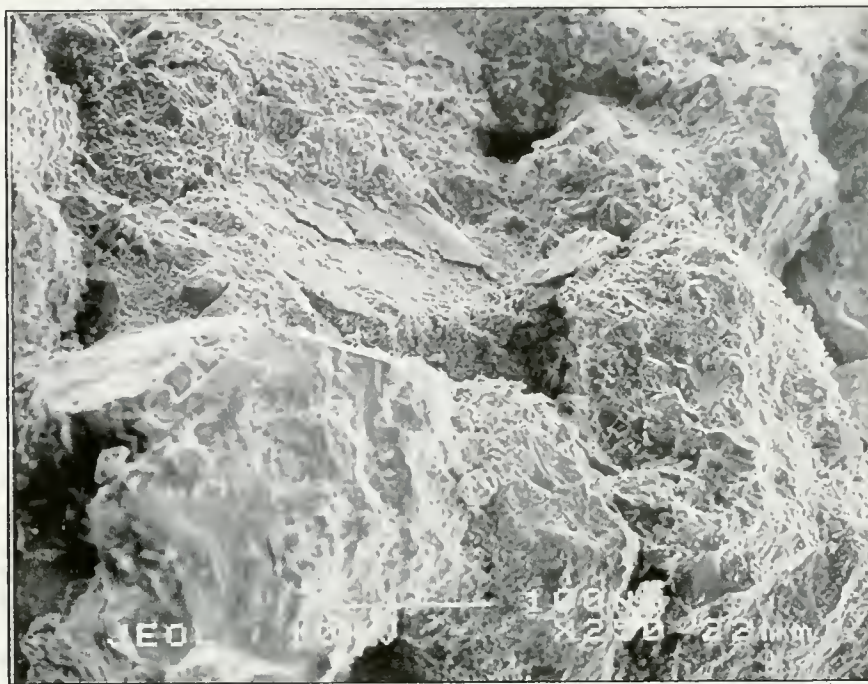
**Fig. 66 - Bethesda Terrace sandstone treated with Brethane (250X – JEOL SEM).**  
Brethane observed as a rough coating over the grains of the Bethesda Terrace sandstone.

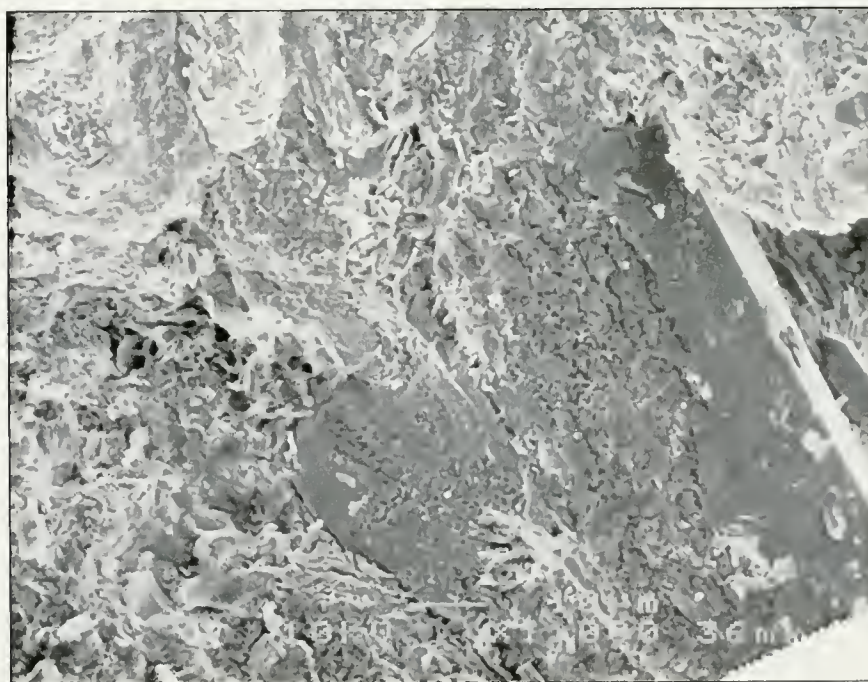
**Fig. 67 - Bethesda Terrace sandstone treated with Brethane (1,000X – JEOL SEM).**  
Brethane is observed as stringy masses adhering to the Bethesda Terrace sandstone grains.
